PROPERTY CONDITION ASSESSMENT
OF
WORLD TRADE CENTER PORTFOLIO

CENTRAL PLANT

FINAL DRAFT

December 6, 2000

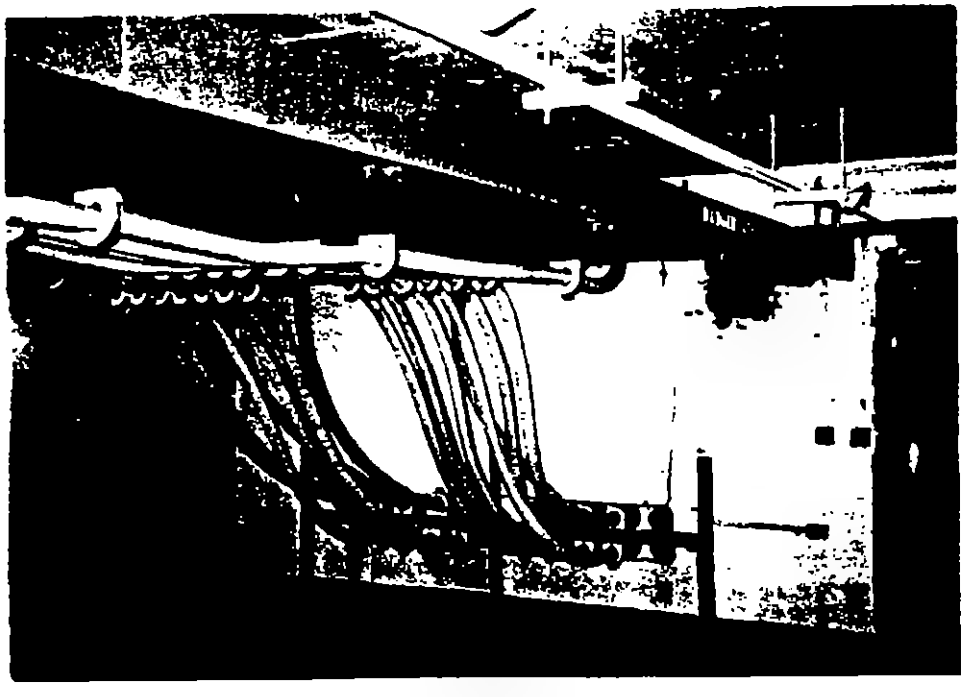
Photograph 18

Recently upgraded high voltage feeders
